CASE STUDY—PITCHED ROOF TILING

WEST KIRBY GRAMMAR SCHOOL, WIRRAL

West Kirby Grammar School

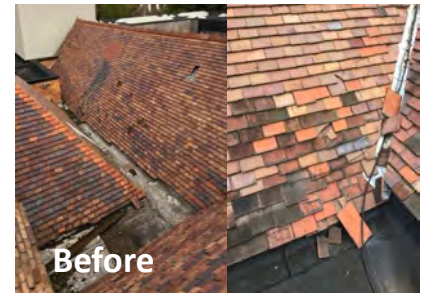
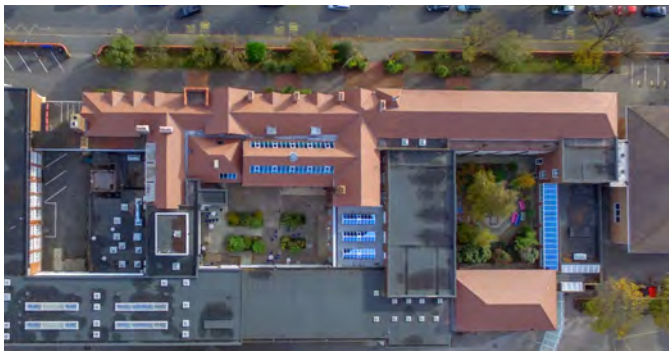
On inspection, the school's old clay tile roof coverings were found to have deteriorated and to be in need of replacement. The roof covering consisted of tiles on battens nailed directly to the timber rafters, with mortar torching to the underside. The detailed survey of the roof identified problems relating to; corroded copper nails, weathered clay tiles of mixed sizes, storm damage, mechanical damage, deteriorated and missing lead flashings, fragile wired glass roof lights, and leaking cast iron gutters.

All-in-all, the roof was not only in a state of disrepair, but didn't comply with the current British Standard in respect of it's installation. It also provided no thermal insulation to the building.
