CASE STUDY—FLAT ROOF REPLACEMENT

CHELMSLEY WOOD CENTRE, BIRMINGHAM

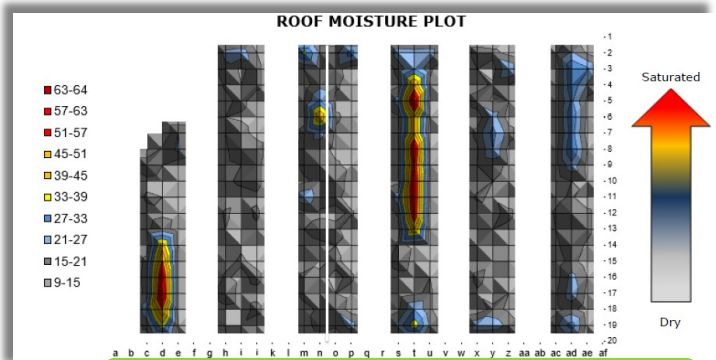
Moisture mapping by Bauder Troxler survey

A moisture mapping exercise by Bauder, using their Troxler moisture detection system identified the areas where water had ingressed into the substrate and which would require full reinstatement. The majority of the roof area was found to be suitable for an overlay with a new bituminous system.

Working to the moisture map provided by Bauder, and supervised by the Bauder site technicians, BBR stripped out the defective areas and reinstated them to a similar level with new insulation. The whole roof area was then overlaid with the Bauderflex system, on a 25mm insulation board to provide isolation between the existing thermoplastic membrane and the new bituminous materials.

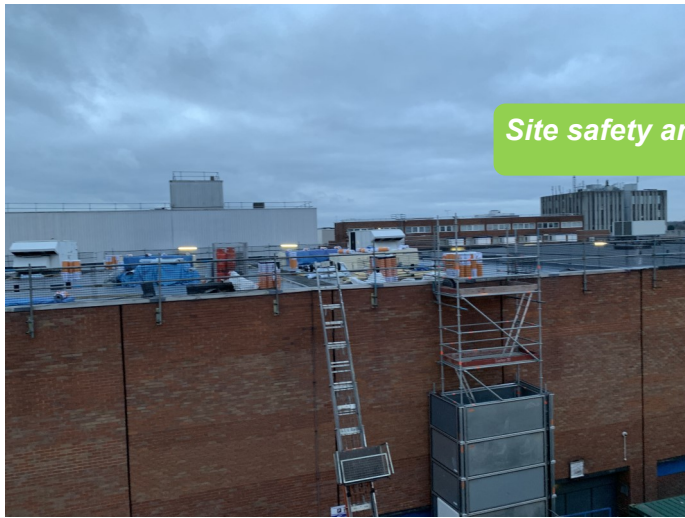
Site safety and attention to detail

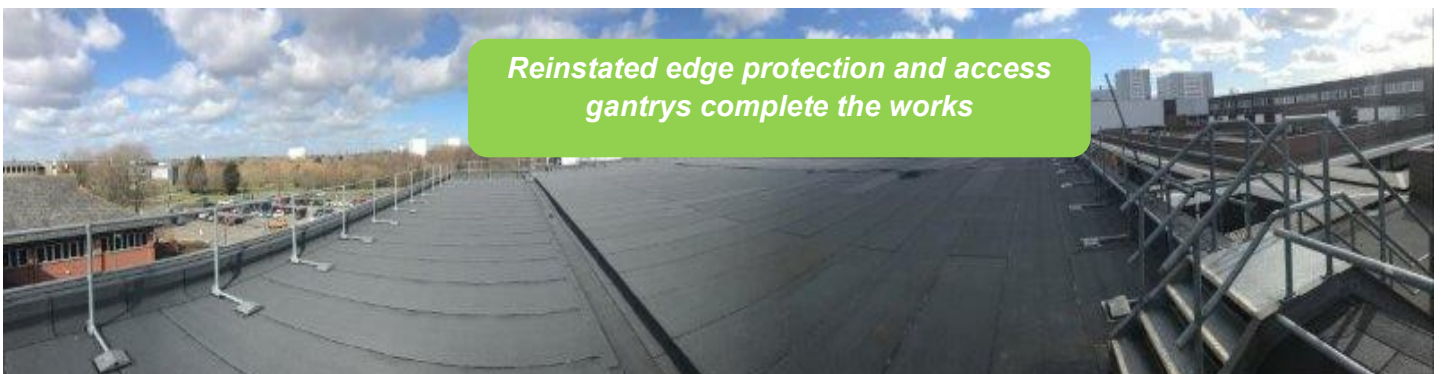
Reinstated edge protection and access gantries complete the works
