## CASE STUDY - FLAT ROOF REFURBISHMENT—OFFICE BUILDING

### *Capital Building, Liverpool*

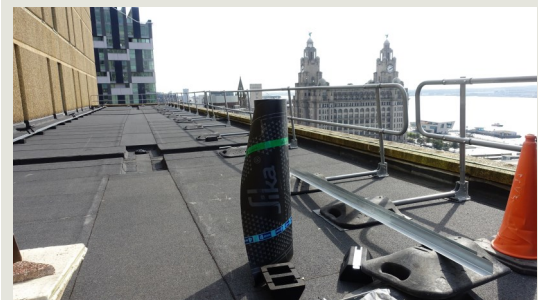
The re-roofing schedule called for the removal of the cement-topped insulation boards and the EPDM single-ply waterproofing membrane.

This exposed the original asphalt waterproofing layer, which was patch repaired where necessary and then incorporated as the vapour-control layer under a new built-up bituminous waterproofing system.

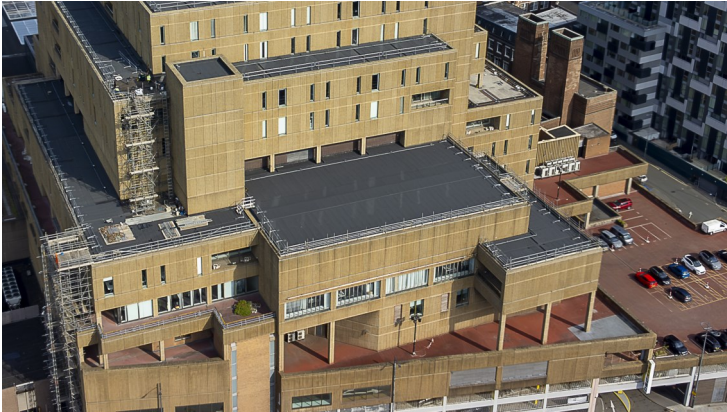
A large open area of flat roof to the front of the building, a former sports hall roof, had a bituminous felt waterproofing and this was overlaid with SIKA self-adhesive vapour-control layer and full build-up as per the asphalt roof areas. The perimeter gutters draining this sports hall roof area had an existing bituminous lining removed and were re-waterproofed with SIKA Decothane 625 liquid-applied waterproofing.
