CASE STUDY - PITCHED ROOF REFURBISHMENT

HALF ACRES PRIMARY ACADEMY CASTLEFORD

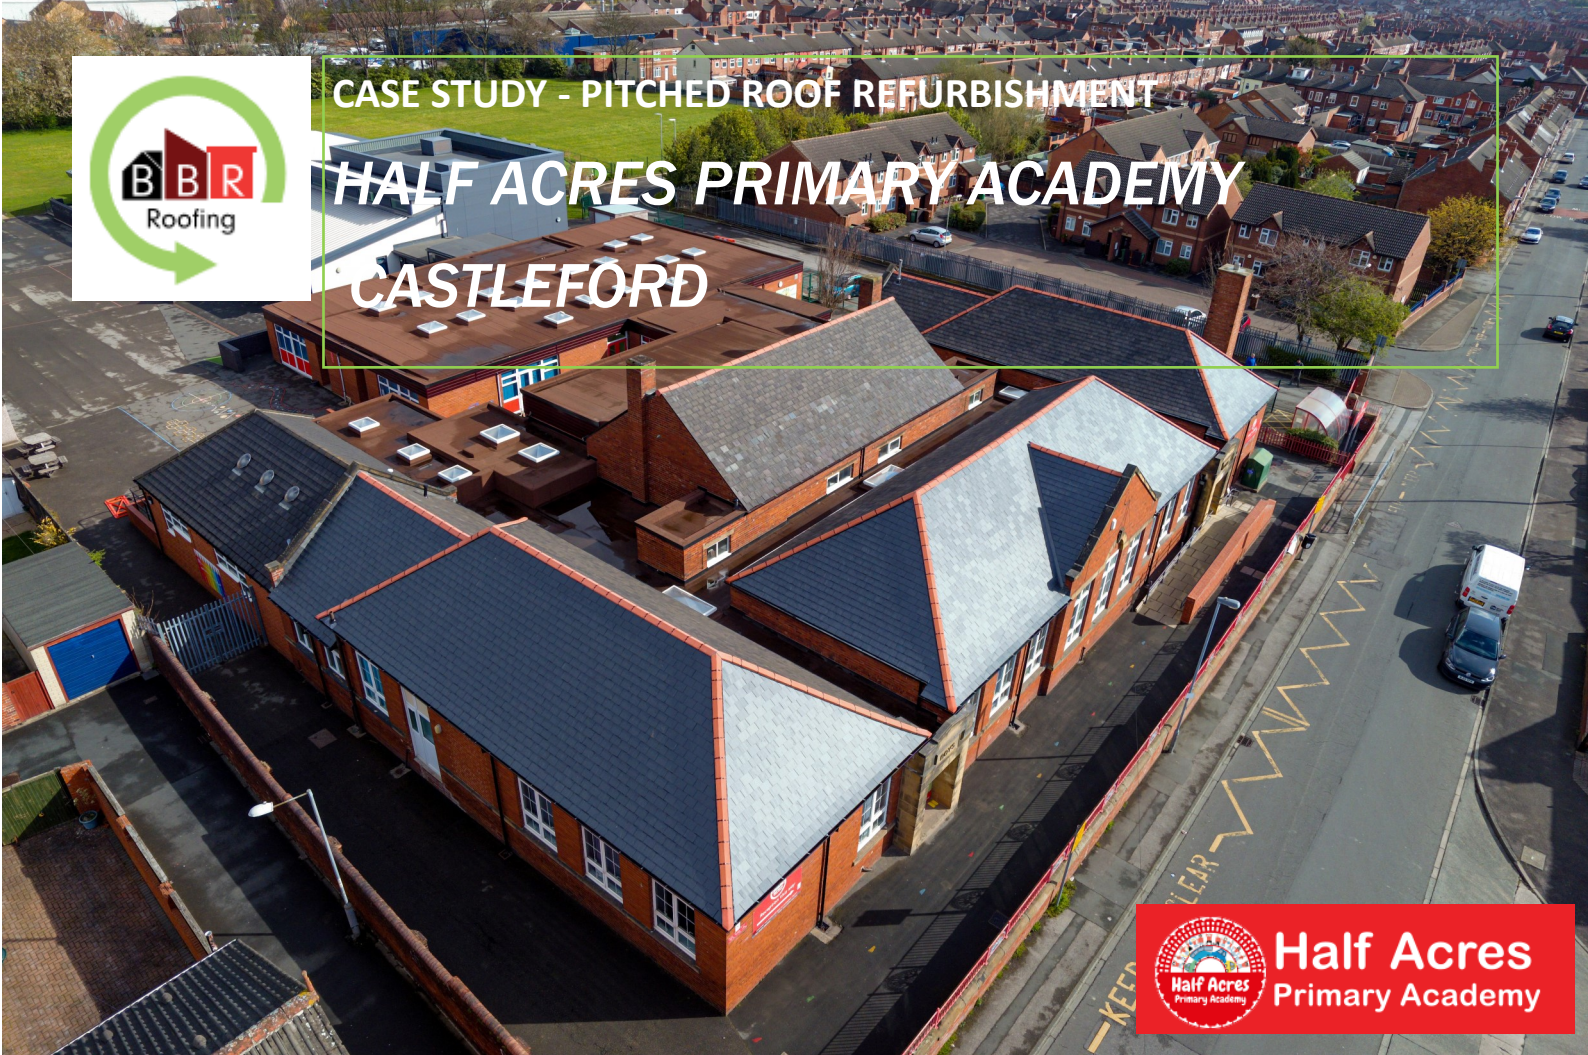
With the striking contrast of the red clay ridge & hip tiles, these refurbished roofs now give the buildings a fresh new overall appearance, as well as providing long term weather-proofing for the school.

On behalf of the school, they specified a full refurbishment of the pitched roof areas which encompassed a full strip to the rafters, installation of ceiling level quilt insulation and replacement of slates on Tyvek vapour permeable underlay and new timber battens.

Ventilation was provided at eaves and ridges, with the ridges and hips being mechanically fixed. All material selection and works were to be carried out in accordance with BS5534.

While it is customary during slate renovation works to reclaim and re-install the good slates and only replace the poor quality ones, for reasons of continuity of the aesthetics it was decided to place all of the reclaimed slates on the rear-most roof areas, and fully replace the front roof areas with new material.
