## CASE STUDY—FLAT & PITCHED ROOF REFURBISHMENT

# BOUGHTON HALL, CHESTER *Retirement village*

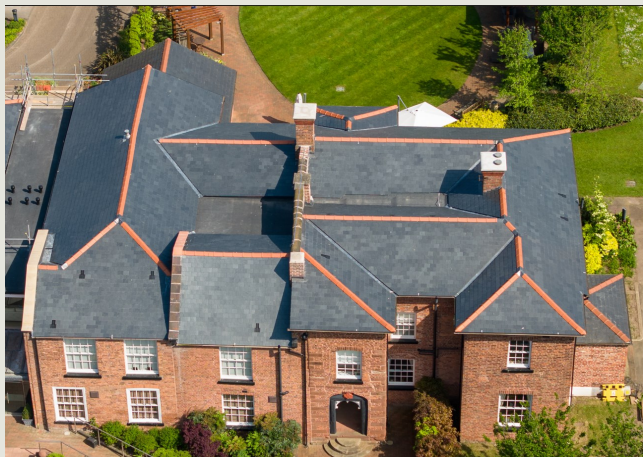
Grade 2 listed Boughton Hall (above)

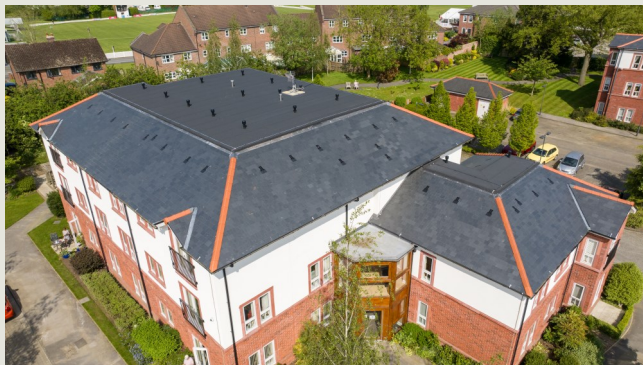
One of the residential blocks (below)
