## The Project

When the roof of this large industrial building housing the manufacture of corrugated sheet board and boxes became due for refurbishment BBR Roofing were appointed by local commercial property surveyors NSW Commercial to carry out the refurbishment.

The overall refurbishment involved re-coating of the entire 21,500m2 profiled metal roof surface, re-waterproofing of the valley gutters, and replacement of 143 barrel-vault roof-lights.

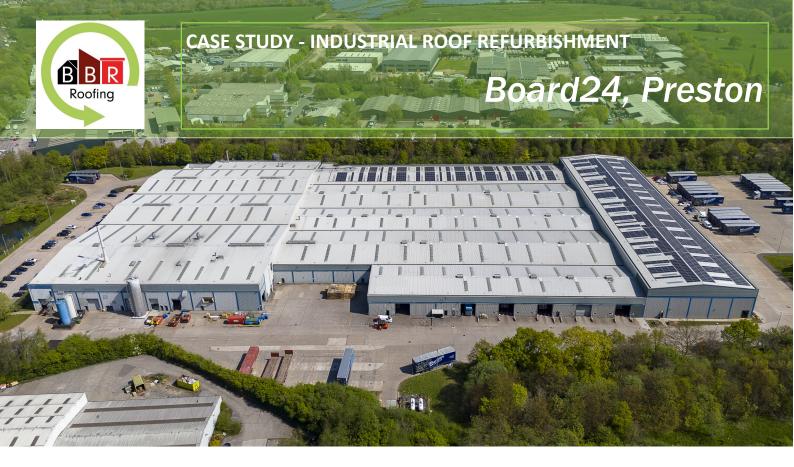
The existing roof covering was cleaned by pressure washing to remove the loose and flaking original coating. The newly cleaned roof sheeting was then primed with Caltech METprime before being covered with two coats of the spray-applied Caltech METcoat, providing a new weathering surface to the metal roof sheeting.

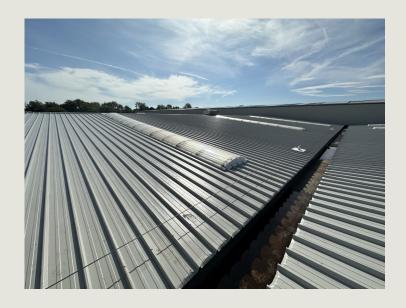
Almost 1 km of gutters, with a girth in excess of 1,000mm were lined with Alumasc's Caltech QC system incorporating reinforcement matting to provide security over the gutter joints.

Caltech QC comprises of a rapid curing twocomponent, cold-applied, fully reinforced PMMA waterproofing solution. The wet-on-wet application with embedded polyester fleece, is quick to install and forms a seamless, durable membrane that is rainproof in just 30 minutes. Reducing installation times and keeping disruption to a minimum.

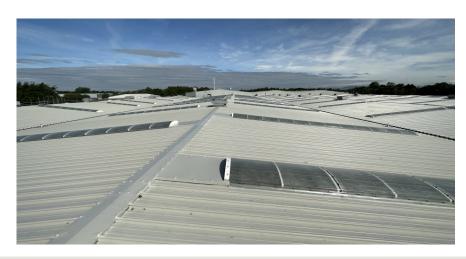
All of the existing barrel-vault roof-lights were also replaced with custom-made Zenon Arc roof-lights by Hambleside Danelaw. In total, 1,74 linear metres of the roof-lights were installed.

The logistics involved in the removal of exiting roof-lights, and replacement with the new products required close cooperation between all parties.

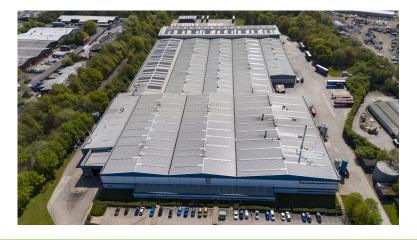
Due to the large scale of the project a major challenge was to achieve successful adhesion and preparation of the damaged roof surfaces within the specified timescales. This was an important consideration as work needed to be carried out with minimal disruption to their manufacturing operations.
